# CONSEQUENCES OF NOT MAINTAINING ADEQUATE RAIL NEUTRAL TEMPERATURE

FRA Track Safety Symposium  
St. Louis, MO  
April 5, 2022

*Brad Kerchof*  
*Advanced Rail Management*  
*Norfolk Southern Railway (retired)*

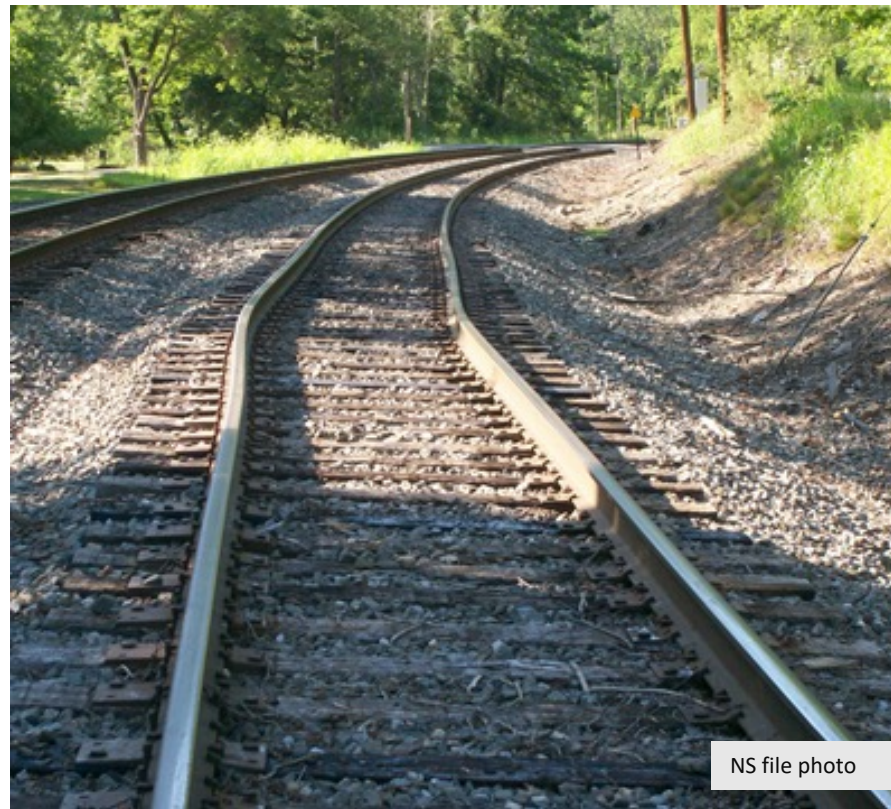
NS file photo

Knowing RNT allows us to manage the risk of buckled track

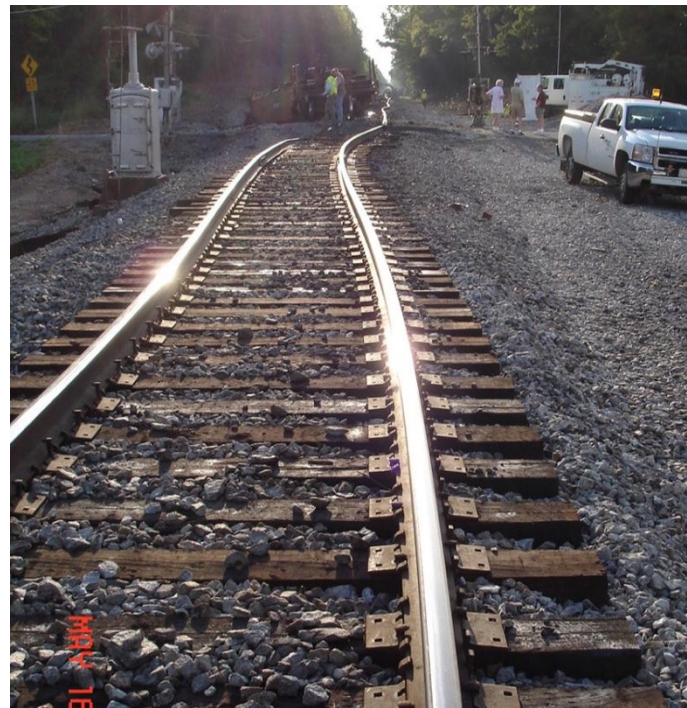
- 150+ ft of rail changed out and welds made at temperatures between 40° & 50°
- Rail added recorded at only one of site
- Neither site was “on the list” for adjustment. Air temps at time of derailment were 83° and 91°

- 40 - 95 ft of rail changed out and welds made at temperatures between 18° and 44°
- Track folks did an excellent job documenting rail added
- Both sites were “on the list” for adjustment
- Track buckled at a surprisingly low air temperature – in the 60’s!

- 1) Most buckled track derailments are related to something that happened during cold weather (track shift, rail change-out or welding) that resulted in a lower RNT.
- 2) How you handle these cold-weather changes to RNT is key to managing your risk of buckled track.
- 3) Keep a record of any trackwork (or curve shifts) that results in a lower RNT. Then adjust that rail at your first opportunity come warm weather.
- 4) Track buckling is determined by  $\Delta T$ , not ambient temperature.
- 5) FRA data shows that the majority of buckled track derailments occur near fixed assets – a turnout, road crossing or bridge. My suspicion: Rail change-outs (and welding) are likely to occur at these locations.
